Transportation Project Report

Draft Project Scoping Report/Final Design Report

Loft Rd over Schenevus Creek (BridgeNY 2021) Bridge Replacement Project Identification Number (PIN): 9755.19 Bridge Identification Number (BIN): 2227620 Town of Maryland Otsego County

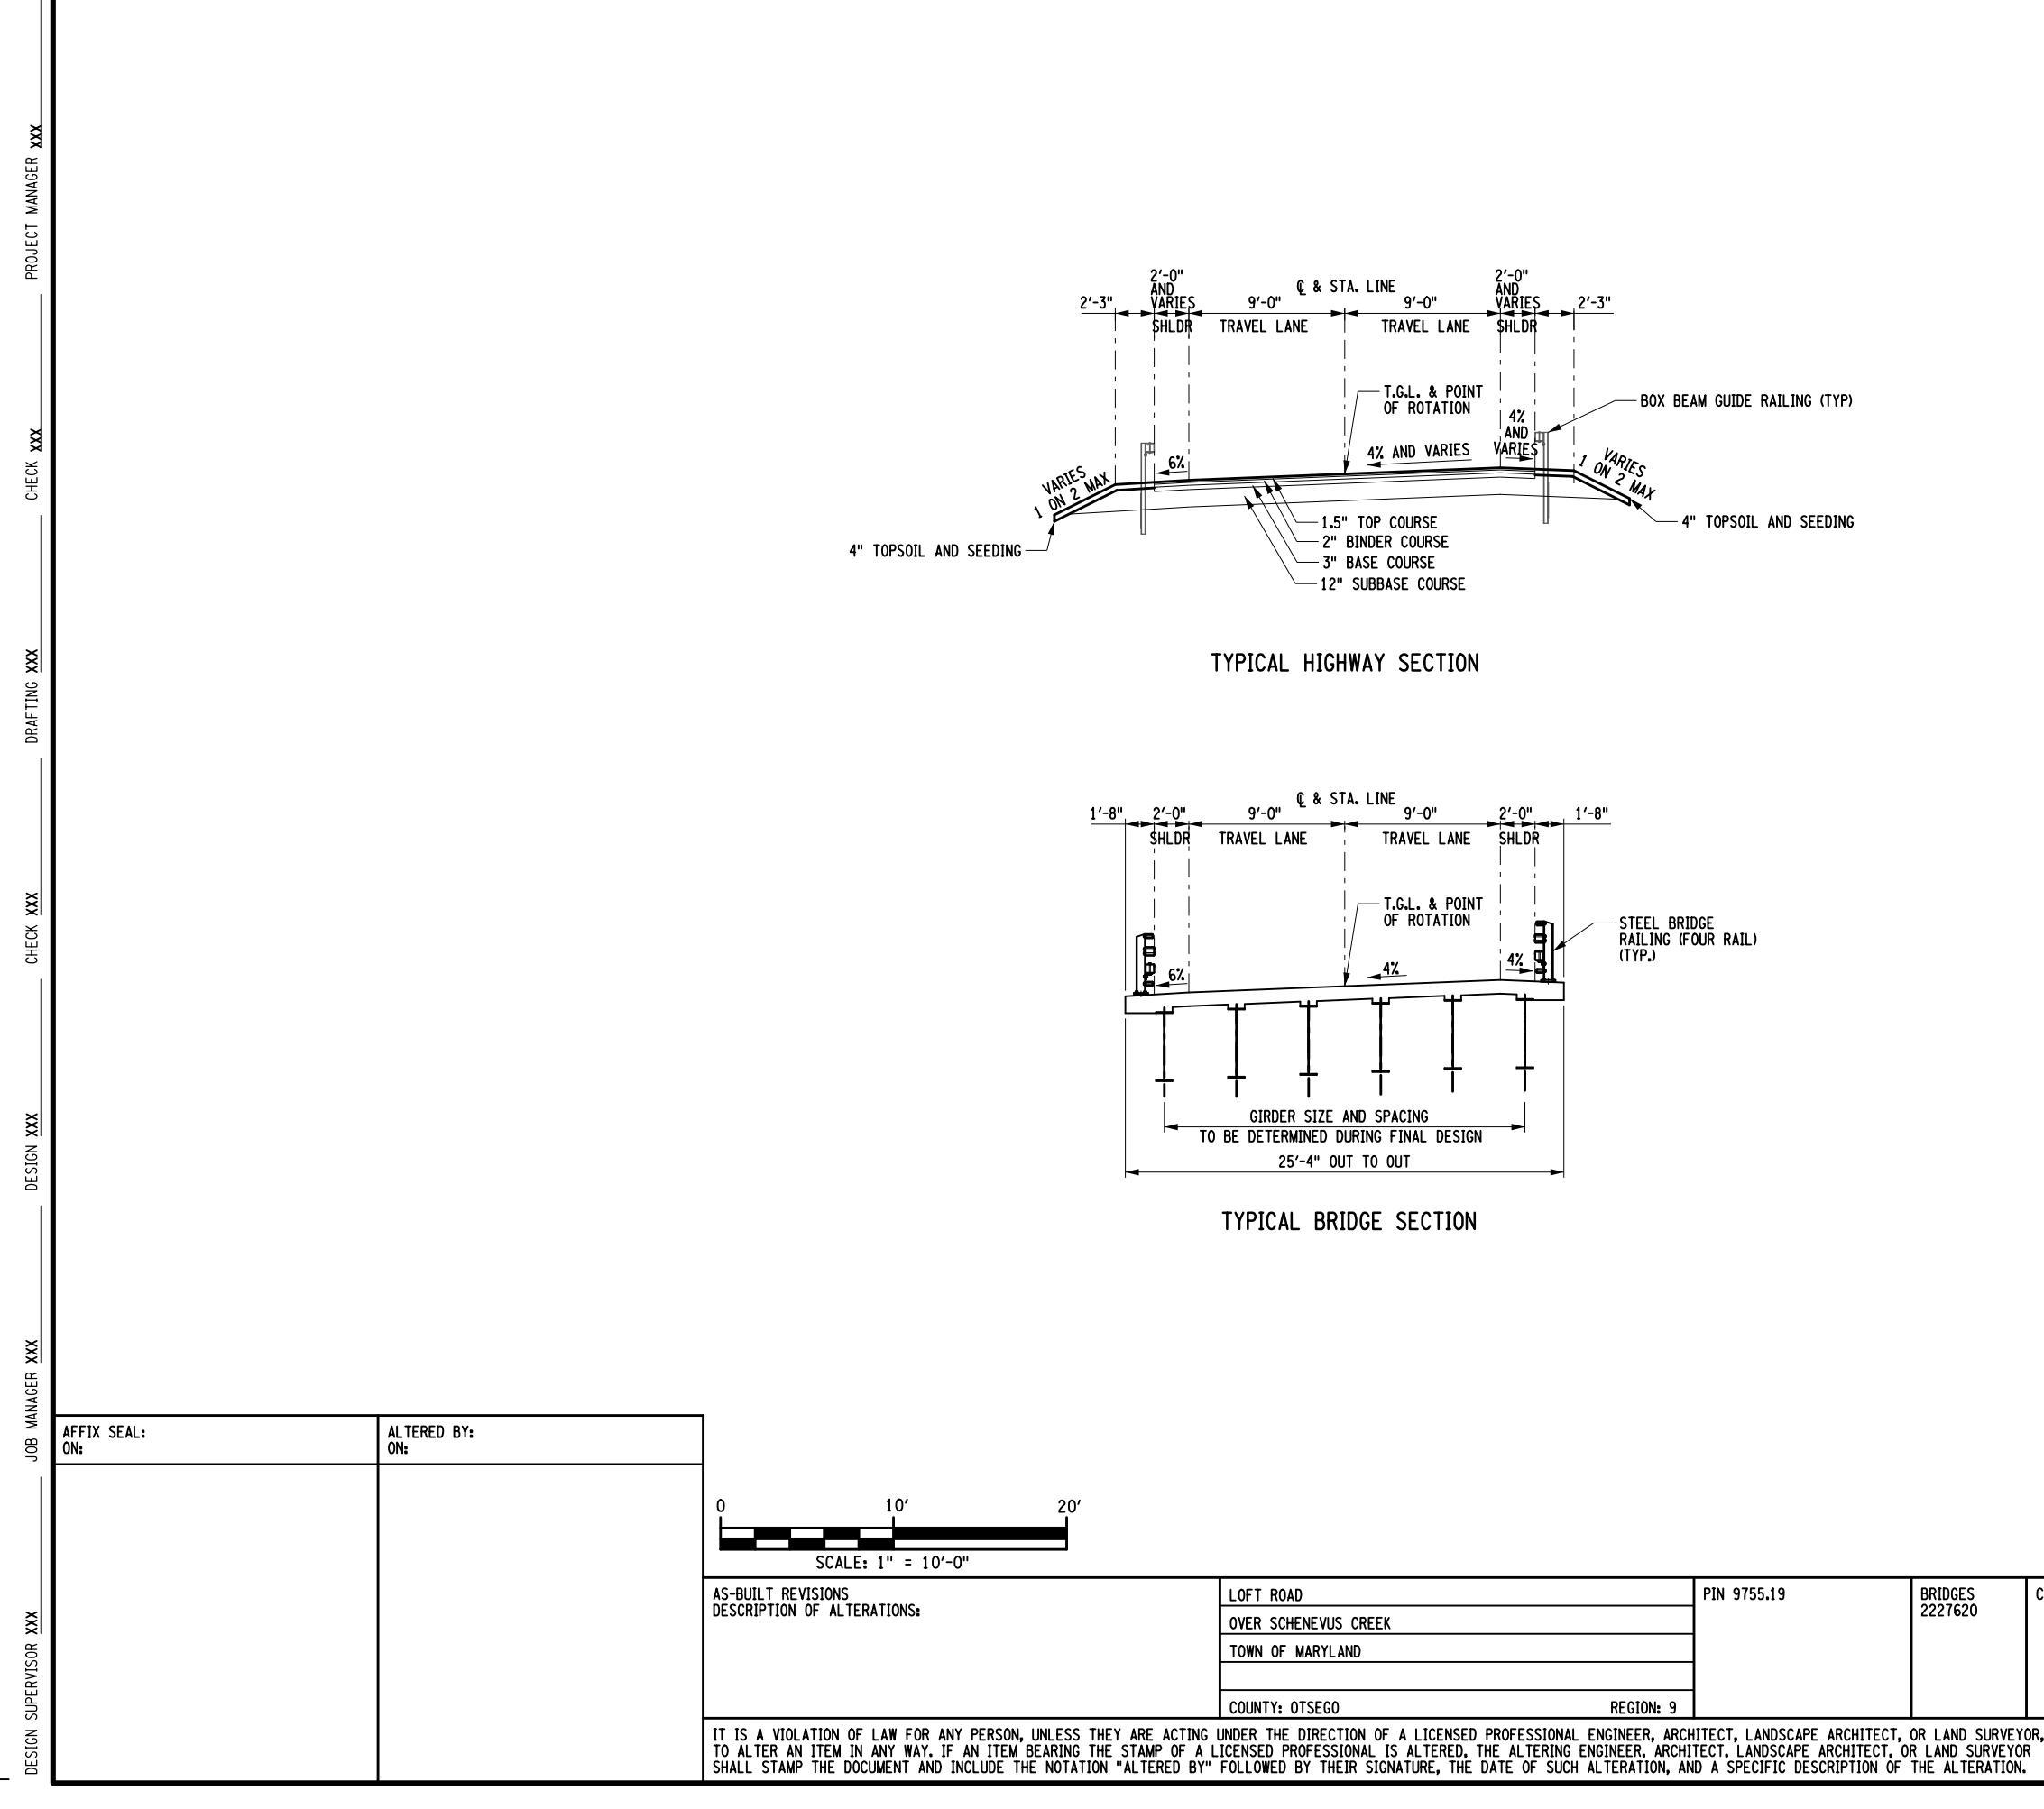
CULVERTS	ALL DIMENSIONS IN ft UNLESS OTHERWISE NOTED		CONTRACT NUMBER
	PROPOSED TYPICAL SECTIONS		DRAWING NO.
			SHEET NO. 5
, ,			MCFARLAND-JOHNSON, INC, 49 COURT STREET, SUITE 240 BINGHAMTON, NEW YORK 13801
